# Landslides in Bhutan

Karma Kuenza, Yeshe Dorji, Dorji Wangda  
Department of Geology & Mines, G.P.O. 173,  
MTI, Thimphu, Bhutan  
Phone: 975-02-322879  
Email: [gsbmti@druknet.net.bt](mailto:gsbmti@druknet.net.bt)

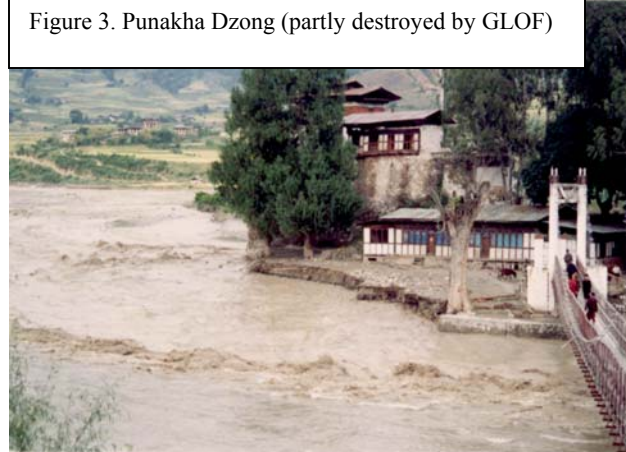
Figure 3. Punakha Dzong (partly destroyed by GLOF)

For instance, in 1994, Luggye glacial lake (Figure 2) outburst in Lunana flooded and damaged rice fields, bridges, houses and the dzongs (Figure 3), demonstrating Bhutan's vulnerability to such extreme events. GLOF and flash floods had also occurred in the same region earlier in 1950, 1960 and 1968.

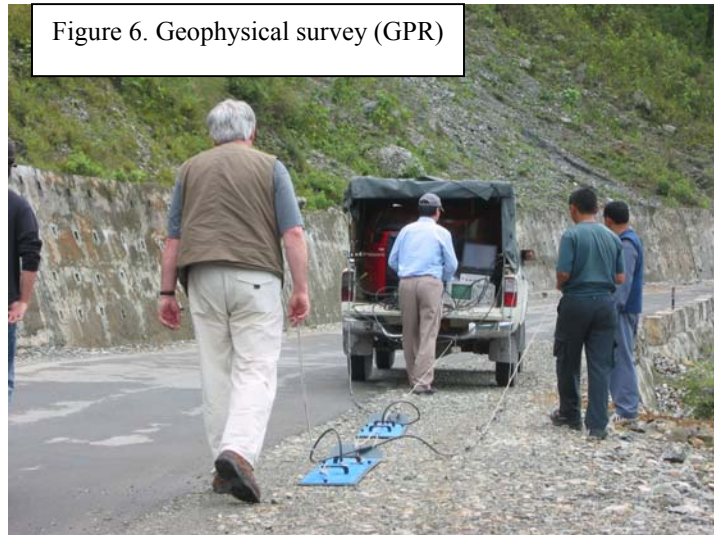
Often the hazard information is plotted on 1:50,000 scale contour maps since they are readily available. However, such maps are inadequate for detailed study of a small project site. Recently, the use of aerial photographs for hazard zonation has become popular. With such photos the mountainous terrain can be mapped quite easily though not exactly. These photos are available on 1:10,000 scales. The above two methods are aided by geophysical methods (Figure 6) to further investigate and understand subsurface geology.
